Manhole Inspection Summary

Manhole # S23K__027MH

Location Address: **S Stricker**

Cross Street: **Ramsey St**

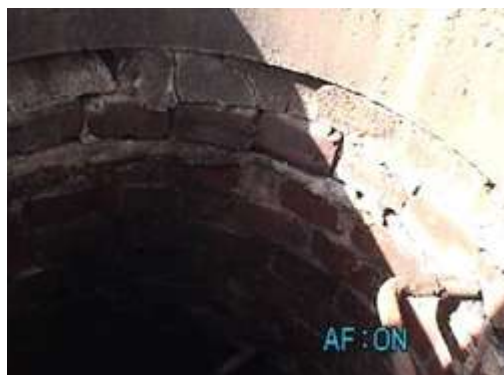
Defect 11

Condition: ☐ Sound ☐ Cracked ☐ Root Intrusion ☒ **Loose Brick** ☐ Deteriorated

Infiltration: ☐ None ☐ Joint ☒ **Cracks** ☒ **Mortar** ☐ Roots ☐ Wall

loose bricks, missing mortar, signs of infiltration @ chimney-frame

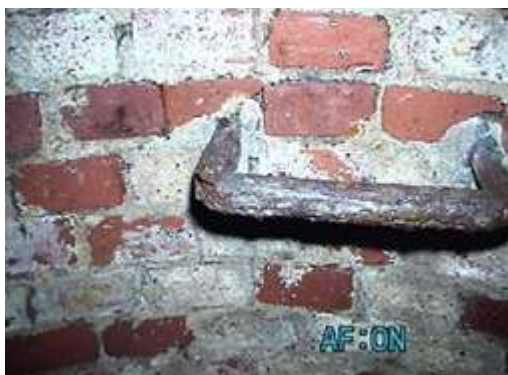
Defect 9

Steps Count: **24** Missing: **0** ☒ **Corroded**

corroded rungs

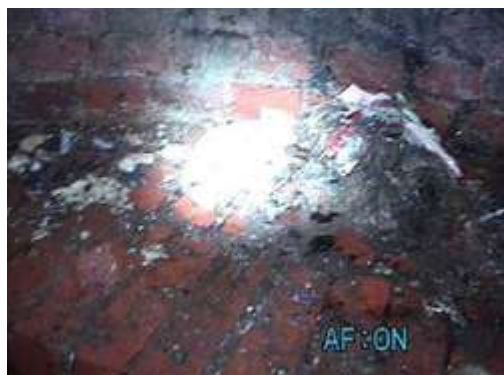
Defect 6

debris on bench

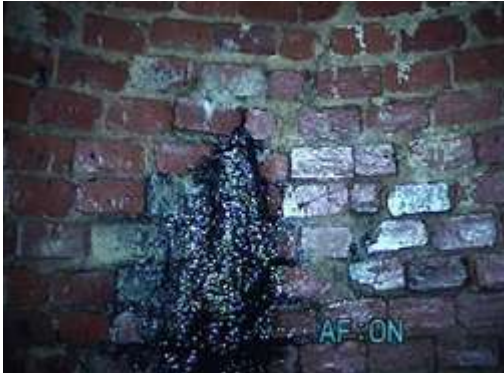
Defect 5

Infiltration: ☐ None ☐ Joint ☐ Cracks ☐ Mortar ☐ Roots ☒ **Wall**

corbel infiltration

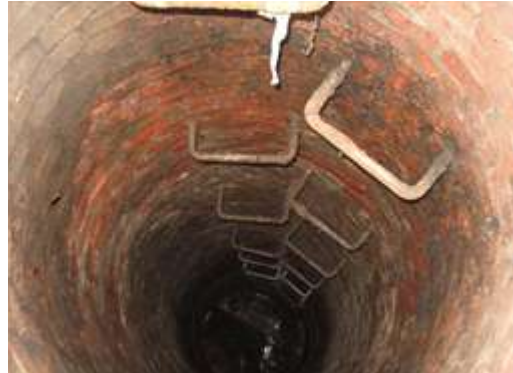
Defect 4

Surcharge ☒ **Evidence Of Surcharge** Depth: **28** (ft.) ☐ Active Surcharge Present

signs of surcharge

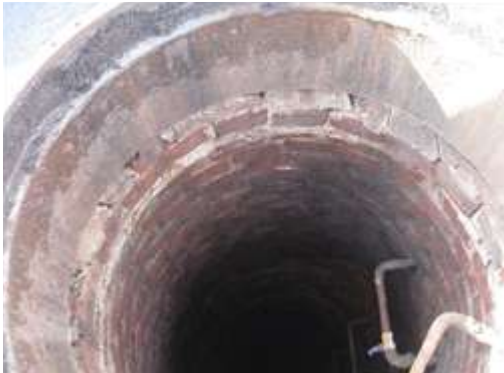
Defect 3

Frame Offset: **0** (in.) Condition: ☐ Sound ☐ Cracked ☒ **Leaks**

infiltration lid-frame

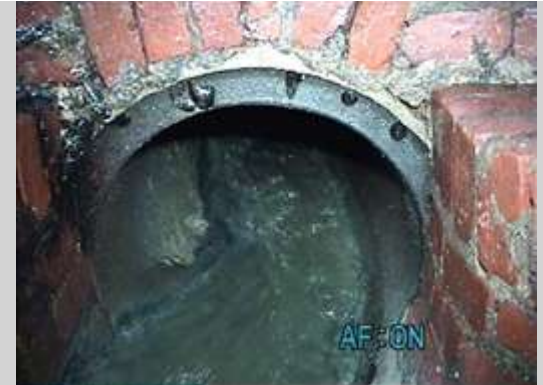
12 O'Clock Outflow

15 in. Circular Gravity Sewer
Pipe Out @ 12 O'Clock

Invert Depth: **30.00** (ft.) Flow Characteristics: **Fast**

Deposits: ☒ None ☐ Mud ☐ Sludge ☐ Debris ☐ Grease

Infiltration: **None** Pipe Seal Cond: **Sound**

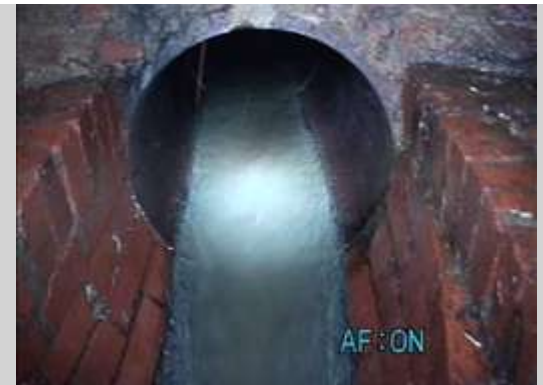
3 O'Clock Inflow

15 in. Circular Gravity Sewer
Pipe In @ 3 O'Clock

Invert Depth: **30.00** (ft.) Flow Characteristics: **Fast**

Deposits: ☒ None ☐ Mud ☐ Sludge ☐ Debris ☐ Grease

Infiltration: **None** Pipe Seal Cond: **Sound**
